Manhole Inspection Summary

Manhole # S35GG_008MH

Insp Date: **3/14/07 1:34 PM**

Location Address: **101 MOUNT ROYAL AVE**

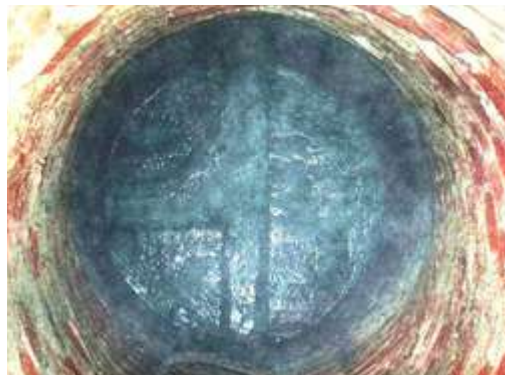
Top View

Storm drain cover

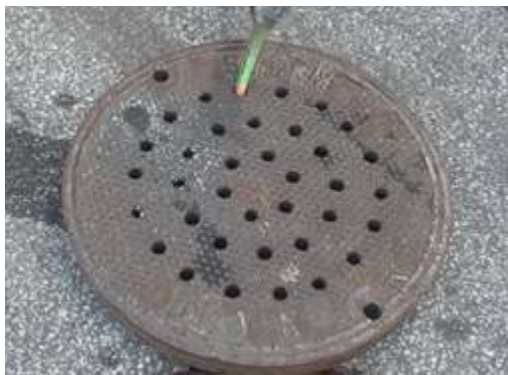
Defect

Frame leaks. Adjustment deterioration and infiltration.

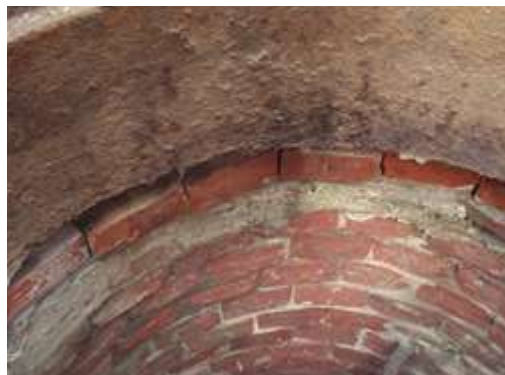
Defect

Frame offset.

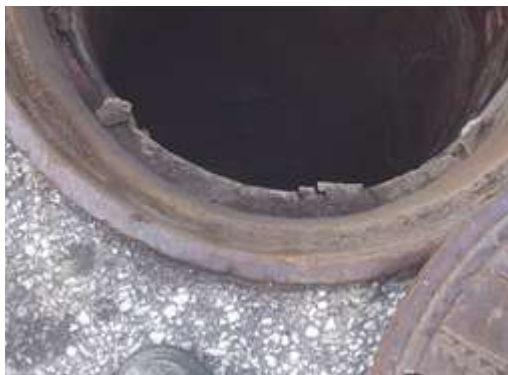
Defect

Adjustment and Corbel deterioration and infiltration.

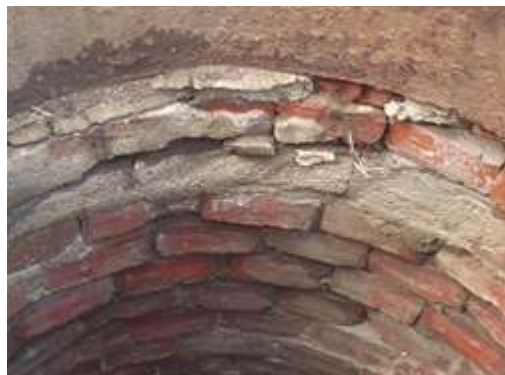
Defect

Corbel and Barrel infiltration. Corroded and missing steps.

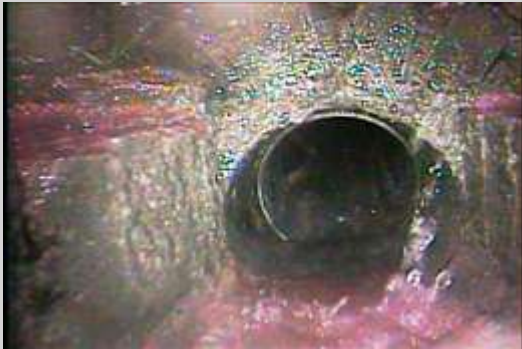
8 in. Circular Gravity Sewer Pipe Out @ 12 O'Clock

Infiltration: **None** Pipe Seal Cond: **Unknown**

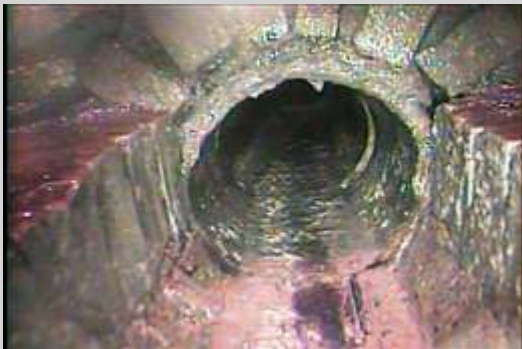
8 in. Circular Gravity Sewer Pipe In @ 6 O'Clock

Deposits: ☐ None ☐ Mud ☐ Sludge ☐ Debris ☒ Grease

Silt Depth: **0** (in.) Deposits Extent: **Light**

Infiltration: **None** Pipe Seal Cond: **Broken**

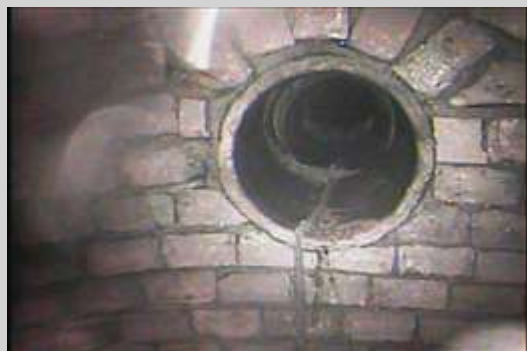
Pipe In @ 9 O'Clock

Infiltration: **Evidence** Pipe Seal Cond: **Cracked**

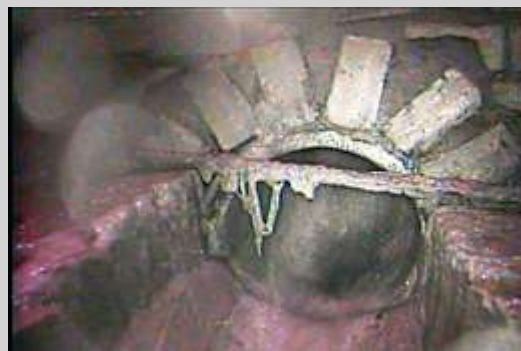
Drop In @ 9 O'Clock

Drop: **Outside** Rod and Bar

Drop Condition: **Open**
